# **ENGINEERING APPROACH TO CONTROL CORROSION UNDER THERMAL INSULATION (CUTI) IN PETROCHEMICAL INDUSTRIES**

**Ali A. Al Beed  
Saudi Petrochemical Company (SADAF)  
P. O. Box 10025 Jubail, KSA**

### **CASE HISTORY**

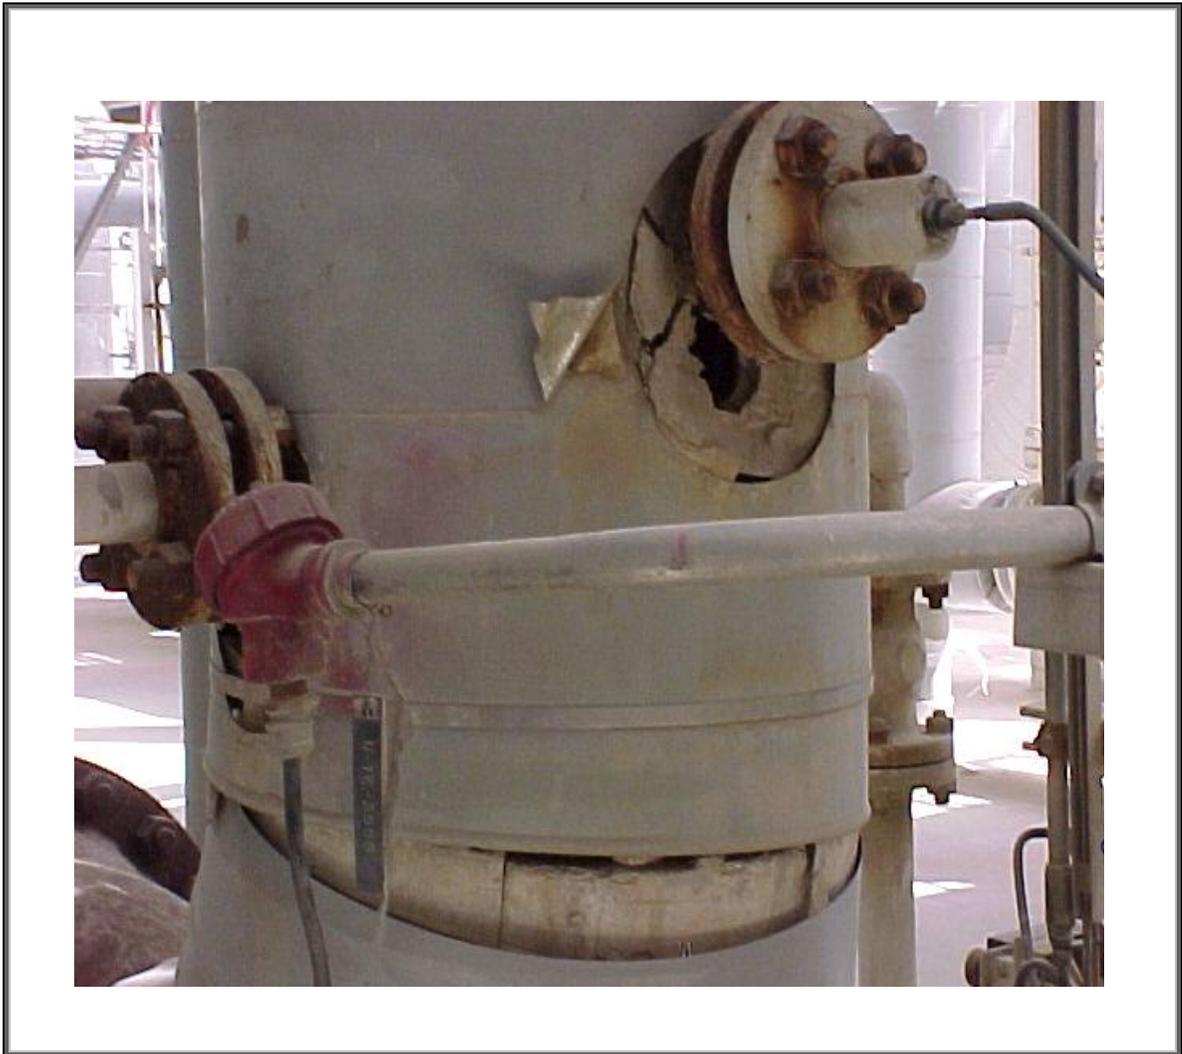
- Bolted-on pipe shoes
  - Steam tracer tubing penetrations
- b) Termination of insulation at flanges and other piping components.
  - c) Damaged or missing insulation jacketing as shown in figure 1
  - d) Termination of insulation in a vertical pipe
  - e) Caulking that has hardened , has separated or missing
  - f) Bulges or staining of the insulation or jacketing system or missing bands

Figure 1 Missing Insulation Jacketing

During the design stage and maintenance practice, attention should be paid to the common piping locations susceptible to CUI to ensure they are well sealed and no moisture gets into the insulation and they are not collecting water. If this practice is applied, then CUI will be controlled in the plant.

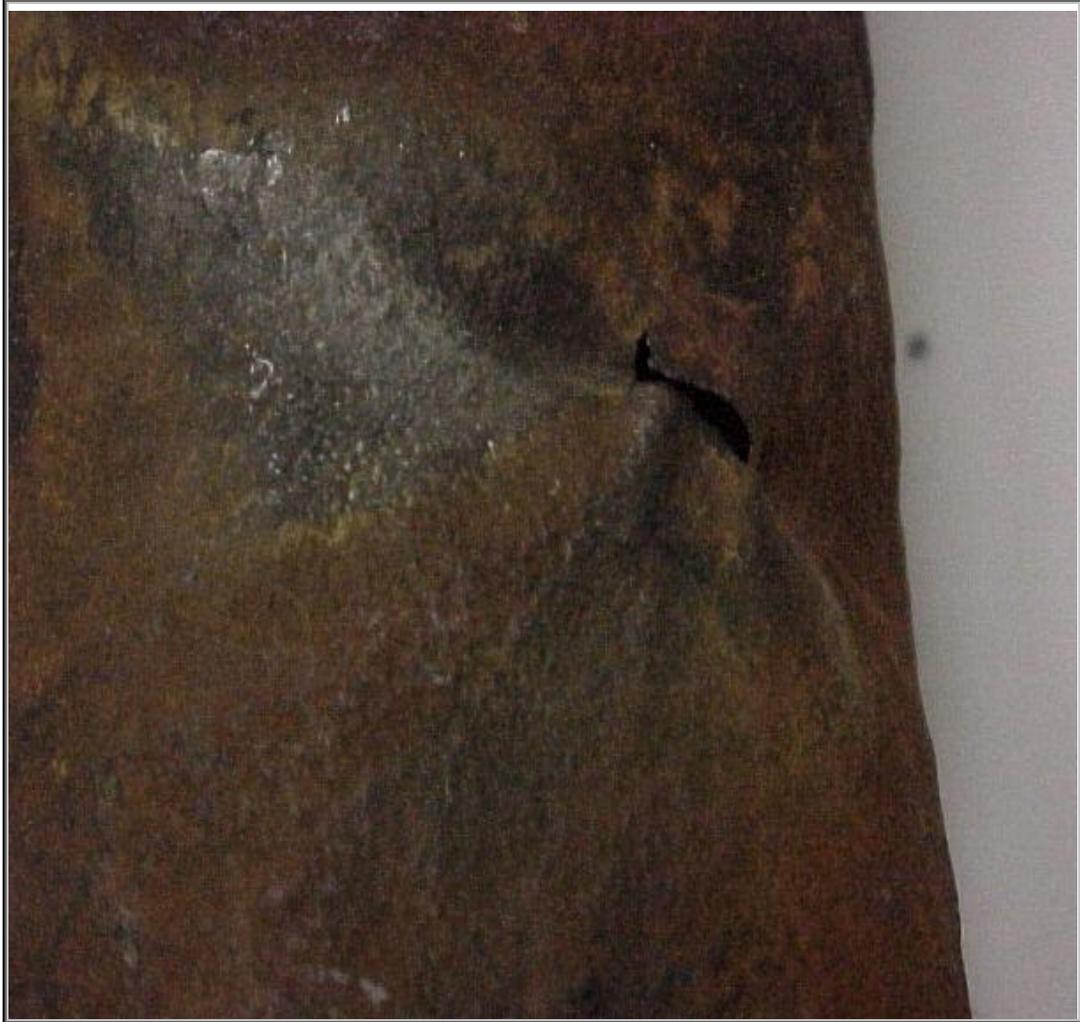
- A leak was found during the unit start up on a 38.1 mm (1.5 inch) start up line coming from 355.6 mm (14 inch) line. This leak was located at the top platform of the process gas dryer 11V70. Visual inspection revealed damaged insulation and Corrosion Under Thermal Insulation (CUTI). The depth of the CUTI appeared to be very significant, down to paper thin around the leak area while the original thickness was 5.08 mm (0.2 inch) as shown in figure 2. The 1.5 inch line was some times used as a step by persons on the plat form, which may cause bending stress. This stress

Figure 2 Failure of the 1.5 inch pipe due to CUI

could be one of the contributing causes to the final failure of the pipe. The leaking line was insulated by Cellular Glass, and coated by Inorganic Zinc. Moreover, number of probable root causes were found as follows:

- The line subjected to cyclic temperature. As mentioned above, there was tail gas introduced into the dryer at two different temperatures 230°C and 65°C other than the normal process gas temperature 12.5°C. This means that there was a cyclic temperature (12.5°C to 230°C).
- Corrosion under thermal insulation (CUTI). Once there was a cyclic temperature, there was moisture generated under the thermal insulation and above the line surface. This moisture worked as a media connecting the anodic areas to the cathodic areas especially since there was an electric connection between both of them, which was

the pipe its self. As a result, corrosion under thermal insulation (CUTI) started to take place.

- The line was more than 12 years in service specially if it is known that there was improper inspection monitoring program, and

No enough CUTI awareness among all personals.

- Replace the pipe
- Use proper coating for cyclic temperature
- Strip all system insulation for inspection
- Apply the same repair for the identical line on 11V69 to avoid a leak in the near future
- Identify all susceptible CUTI areas in Ethylene & other units
- Add all CUTI lines in the piping monitoring program
- Strip the insulation when NDT shows problems
- Establish CUTI procedure
- Prepare a plan to inspect all susceptible CUTI lines, and
- Increase the awareness among the Inspectors & Operations.
