More Lessons “Re-Learned” from Corrosion Under Insulation

The incident – the failure of a 8 inch carbon steel, high pressure hydrocarbon line due to Corrosion Under Insulation

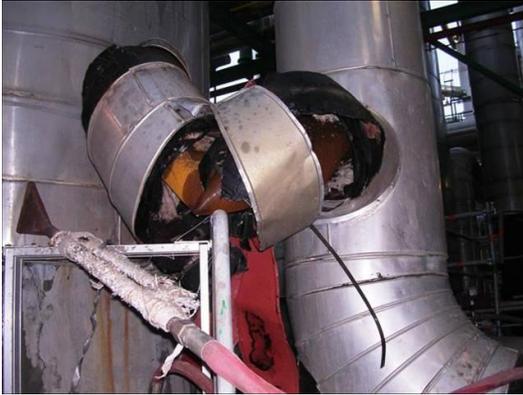
On March 13, 2008, at a Dow’s LHC plant, an 8 inch, schedule 20, carbon steel hydrocarbon line failed. The event began with a small pinhole leak, detected by the operators. While the operators were isolating and de-pressuring the line, it failed catastrophically. Fortunately, this catastrophic line failure produced such explosive force that the line bent in two locations – essentially sealing itself and avoiding a major release.

Fig. 1 - photo of the failed 8" pipe

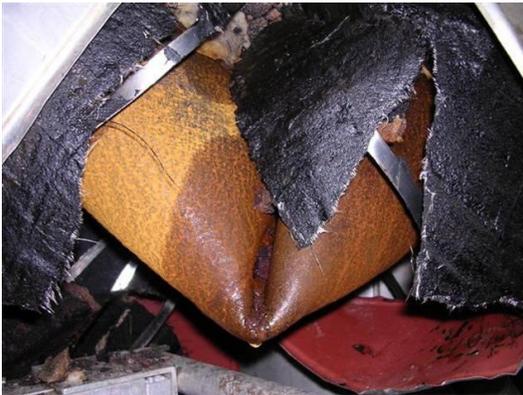
Fig. 2 – photo of the crease in pipe self-sealing the leak

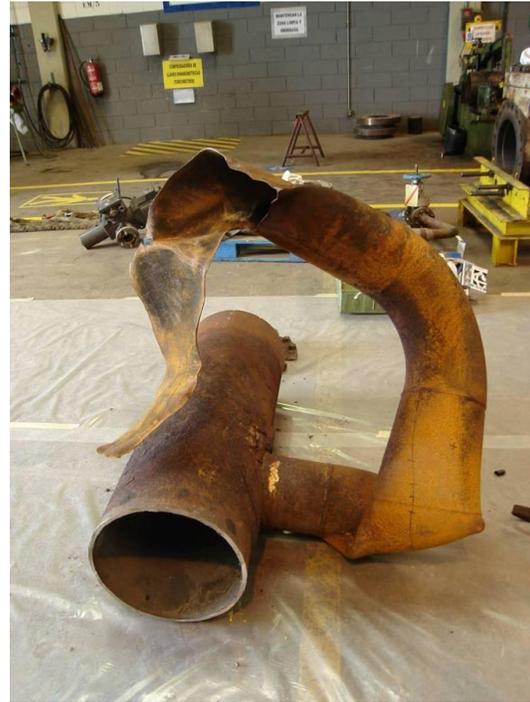
Fig 3 – photo of pipe once removed

Upon reviewing the inspection records, and discovery of the amount of corrosion under insulation at the point of failure, it was clear that neither the inspection in 2004 nor any of the earlier inspections, had been performed in accordance with API 570. Specifically, insufficient insulation was removed to allow adequate external inspection. Instead, only a small plug of insulation at the elbow was removed, under the assumption that the elbow was the most critical inspection location.

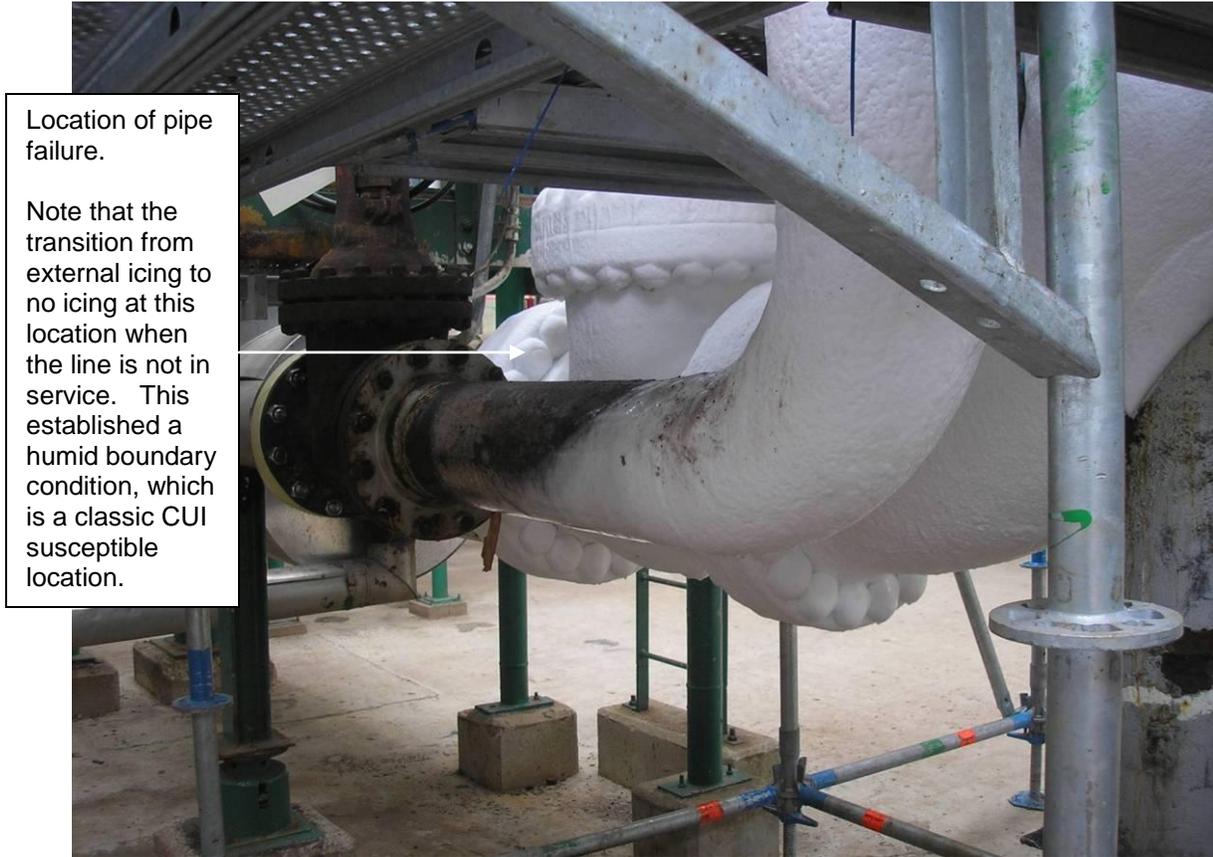
The piping was a 30 year old, schedule 20, carbon steel regeneration line to a cracked gas dryer of an ethylene plant (one of two parallel drying trains). The material in the line was non-corrosive hydrocarbon cracked gas (40% ethylene). Due to the regeneration service, the piping alternates between three different conditions, and the location of failure was where operating temperatures cause frequent or continuous condensation and re-evaporation of atmospheric moisture:

- Regeneration condition (4 bar, 220° C)
- On stream time: 20 days (30 bar, -17° C)
- Regeneration time: 24 hrs (220° C)
- Standby: 19 days (ambient temperature)

Figure 4 – photo showing installed piping when out of service
