Inspecting for Galvanization-related Cracking in Steel Structures

Visual inspection is not always capable of discovering cracks in galvanized metal

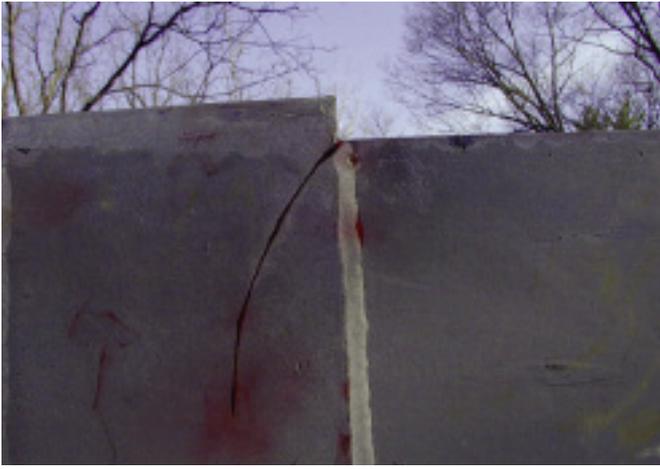
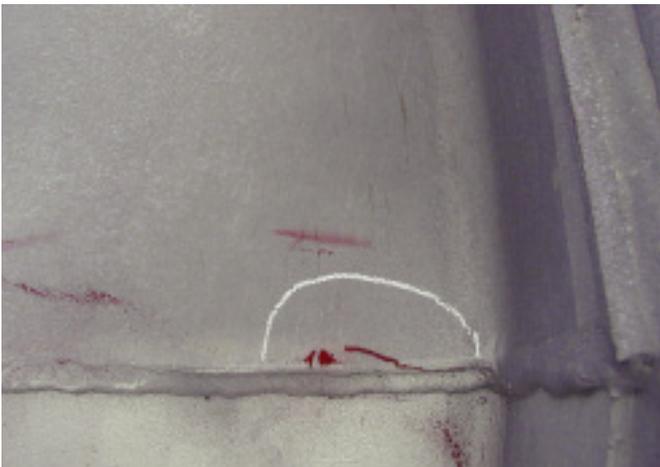
Fig. 1 — Three examples of cracks that weren't visible originally, but which showed up through use of magnetic particle testing.

Figure 1 shows cracks that were not visible to the eye because they were completely bridged by galvanizing. As you can see, they became very visible through the use of magnetic particle methods.
