ULTRASONIC INSPECTION OF PIPELINE SPLIT-TEES

F.H. Dijkstra¹, N. Pörtzgen¹, and H.A.M. van Merriënboer²

Abstract: For repair and hot-tapping of pipelines in the field, often so-called repair sleeves or split-tees are used. These consist of two semi-circular pipe segments, joined by two longitudinal welds and attached to the pipe by two circumferential fillet welds.

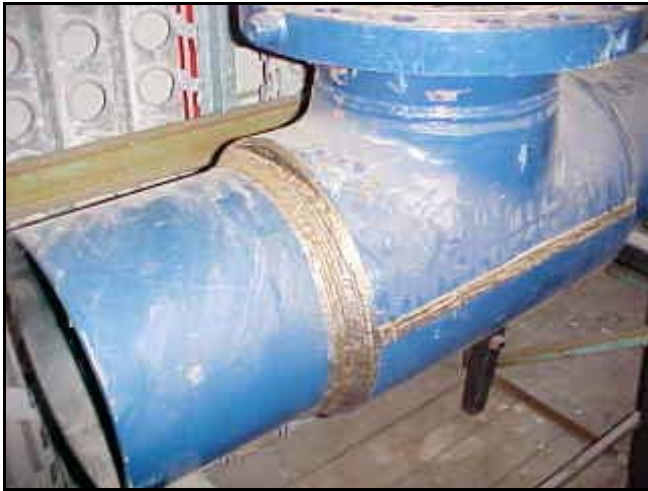
Fig. 1: Typical Split-tee in lab. Photograph: Gasunie.

This paper summarizes results of the modeling study, experiments and preliminary conclusions for future split-tee welding and NDT. The typical geometry of a split-tee fillet weld is shown in fig. 1. Fig. 2 shows a split-tee during welding in the field.

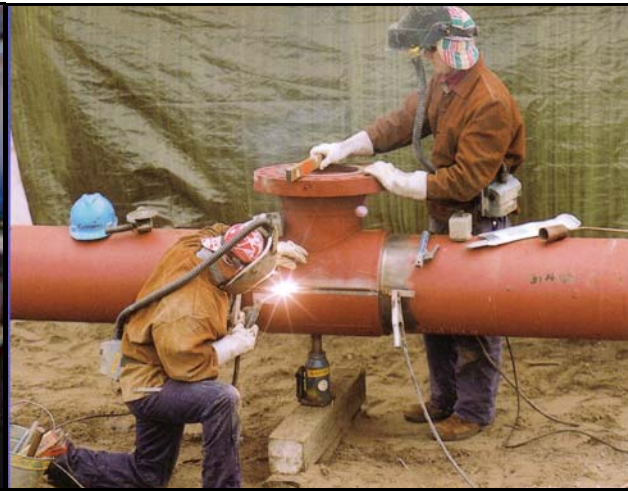
Fig. 2: Split-tee during welding. Photograph: Gasunie.

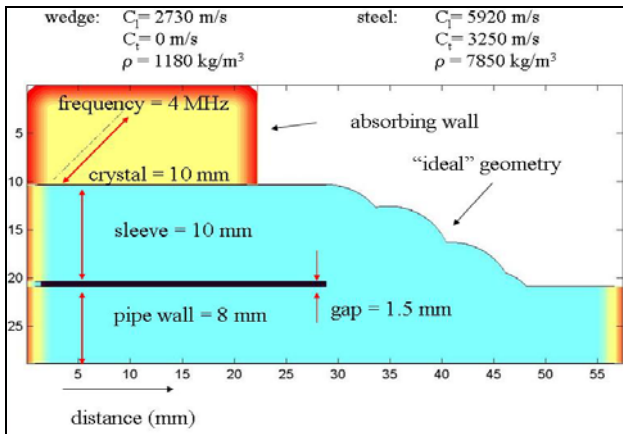
Fig. 4: Ultrasonic and material parameters

In fig. 4, the situation and the primary parameter settings (starting conditions) for the simulations on the thinner sleeve (10 mm) on the "ideal" geometry are shown. In fig. 5, the geometric parameters and defect types (boundary conditions) are shown. For this figure, a macro photograph of a split-tee fillet weld was used. Varying all combinations of these parameters, the total number of simulations amounted to approx. 200.

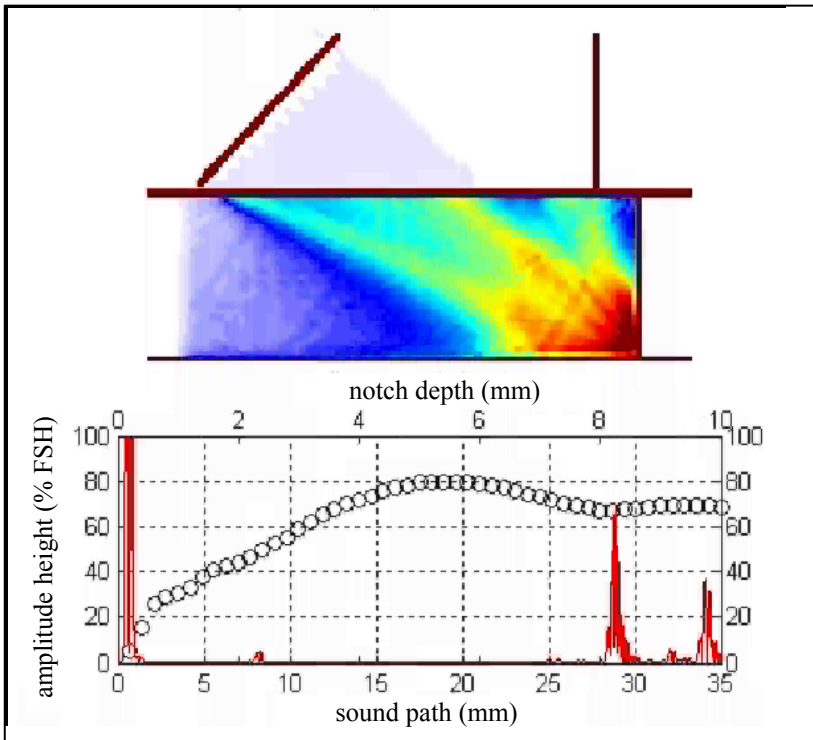
Fig. 7: Amplitude as a function of defect height (fusion defect, corner effect)

- On vertical fusion defects in the vertical fusion line, there is a good relationship between defect height and amplitude for defects up to approx. 4 mm. Above that height, amplitude is saturated and, on defects higher than 6 mm, even reduced. As a result, large defects (8 mm and up) give an amplitude comparable to that of much smaller defects (e.g. 3 mm). This effect is especially present when 60 and 70° probes are used on defects originating from the gap (inside of the sleeve). This means that discrimination between small and very large defects on the basis of corner effect alone will not be possible. This is shown in the graph of fig. 7, which is the result of a series of simulations whereby defect height was increased in 0,2 mm increments and the amplitude

for each situation was stored. Simulated reference sensitivity was 80% screen height on a 5 mm high defect, in order to keep the signals within the dynamic range. The top half of the figure shows intensities in the ultrasonic beam.

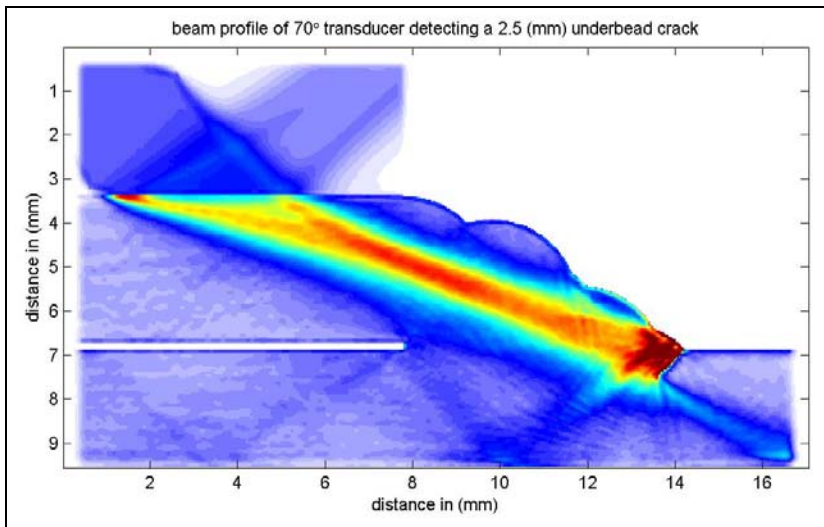
Fig. 8: Beam intensity on underbead defect

- Fig. 8 shows a simulation on an underbead crack at the weld's toe under an angle of 45°, detected through the weld using a 70° probe placed on the sleeve. The beam intensity is visualized. Fig. 9B shows, as an example, the situation that the wave front has just passed the crystal after having been reflected on the defect (captured image of moving wave front simulation). The A-scan (second echo, black) shows an amplitude that is approx. 6 dB lower than the reference echo (first signal, red), which is equivalent to 80% screen height on a 2 mm high notch using corner effect (captured before at the optimum probe position for that particular reflector). In fig. 9A, the wave front is about to hit the defect. This type of simulations showed that this is a good way to detect underbead cracks at the weld's toe, without significant influence of the (varying) weld geometry as long as it is within visual inspection acceptance limits. Sensitivity has to be slightly higher than 80% FSH on a 2 mm notch.
